National Dam Inspection Program.

Strack's Dam (NDI Number PA-00596,  
DER Number 38-20), Delaware River Basin,  
Lebanon County, Pennsylvania. Phase I  
Inspection Report.

PHASE I REPORT  
NATIONAL DAM INSPECTION PROGRAM  
BRIEF ASSESSMENT OF GENERAL CONDITIONS  
AND RECOMMENDATIONS

Name of Dam: STRACK'S DAM, NDI NO. PA-00596  
State & State No: PENNSYLVANIA, 38-20  
County: LEBANON  
Stream: TRIBUTARY TO TULPEHOCKEN CREEK  
Date of Inspection: April 6, 1979

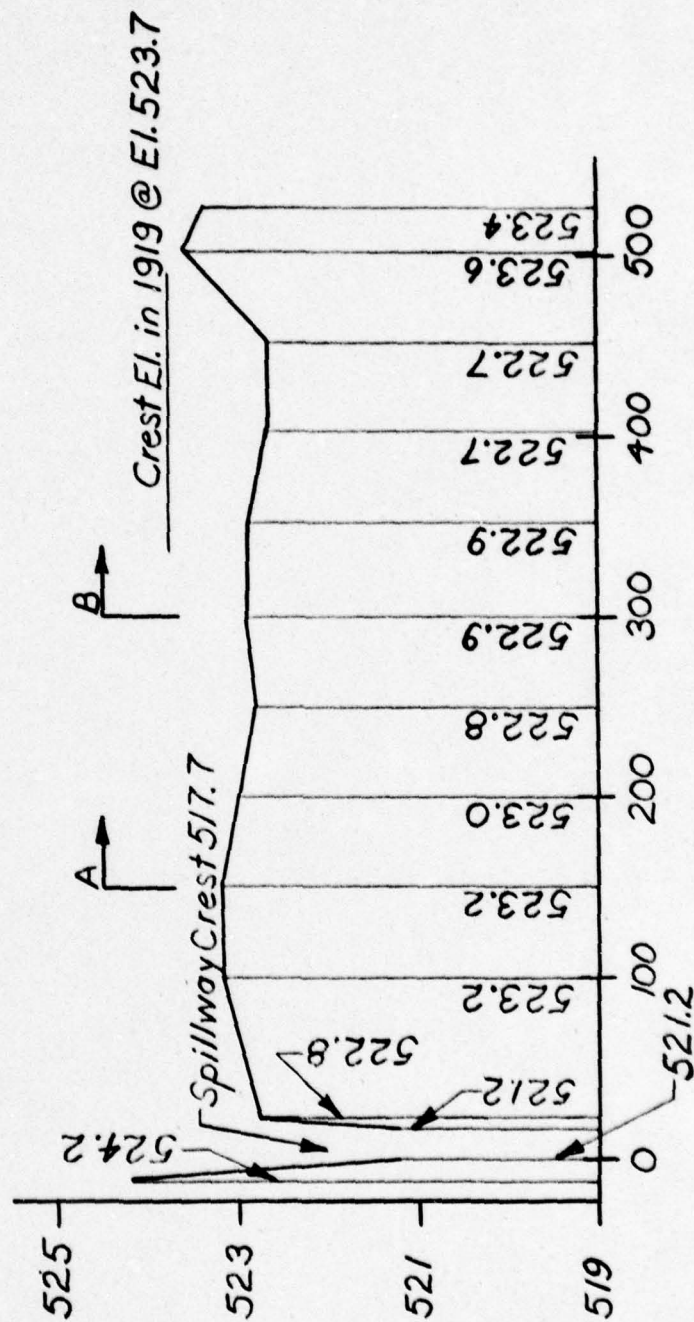
EMBANKMENT PROFILE

The upstream slope of the dam was in fair condition and appears to be stable. Several gullies were evident at the top and several trees on the slope should be removed. Old stumps of previously cut trees indicate that many large trees were on this slope. The top of the dam has some light brush and a dirt footpath, indicating that the breast is extensively used by fishermen. The profile of the crest was surveyed (see Plate A-II, Appendix A) and appears to be below the design elevation.

D. ALIGNMENT OF CREST: HORIZONTAL: VERTICAL:	Horizontal alignment good. Vertical - See profile Plate A-II.
E. RIPRAP FAILURES	No riprap, except some stone at waterline.

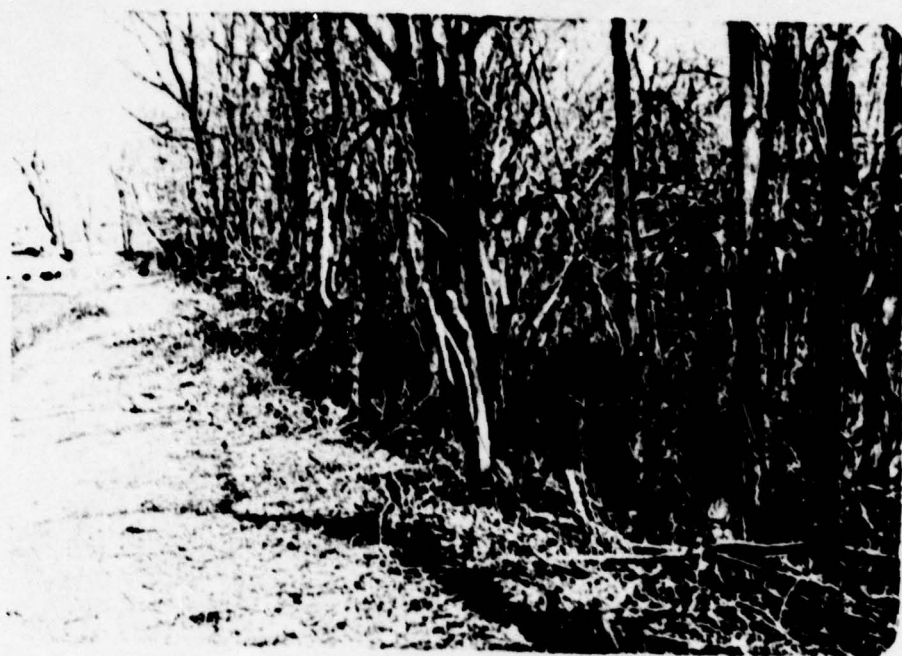
The downstream slope has a dense growth of brush and trees, with trees up to 18 inches in diameter. The brush prevents close observation of the slope and sloughage or slippage areas were not noticed. The slope is, however, saturated and soft over most of its height. At the toe and downstream of the toe, the ground is totally saturated, marshy and soft. The soft condition of the slope has caused some trees to be uprooted and it is feared that additional uprooting of trees could occur. The subsurface drainage system installed on the downstream slope and in the toe is not functioning properly.

Dam Crest and Downstream Slope

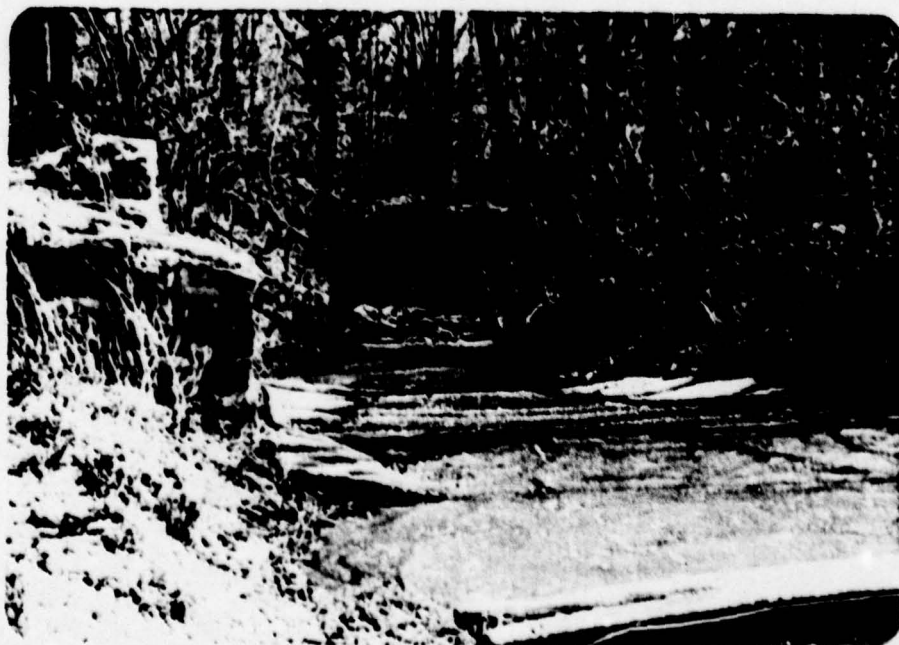
The spillway weir was in fair condition and slightly dipped towards the center. The approach has no training walls and a large discharge over the weir could cause erosion to the right of the spillway. The abutment walls of the spillway are short and low. The spillway chute is paved over 35 feet of its length and further erosion of this channel, downstream of the weir, can be expected.

Spillway

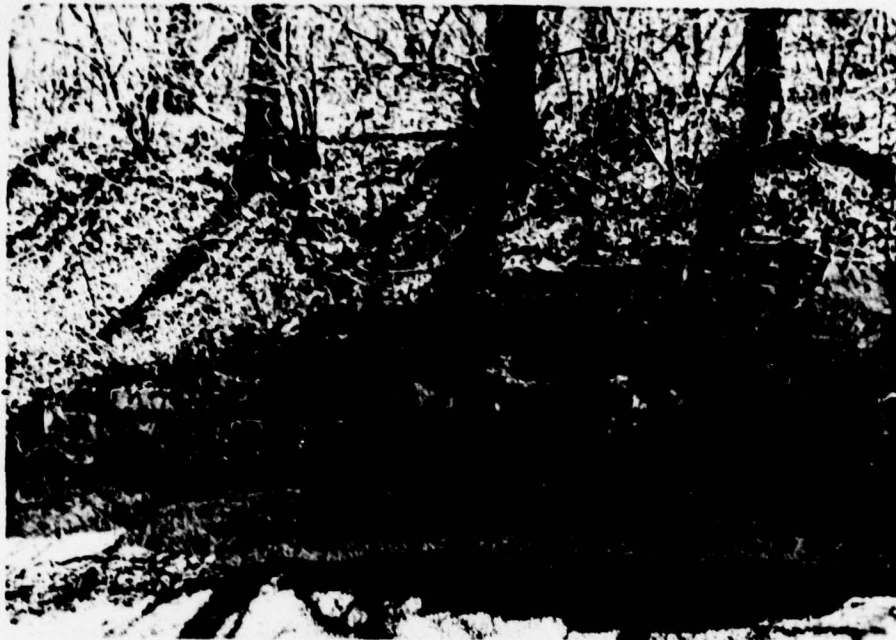
Right Abutment of Spillway

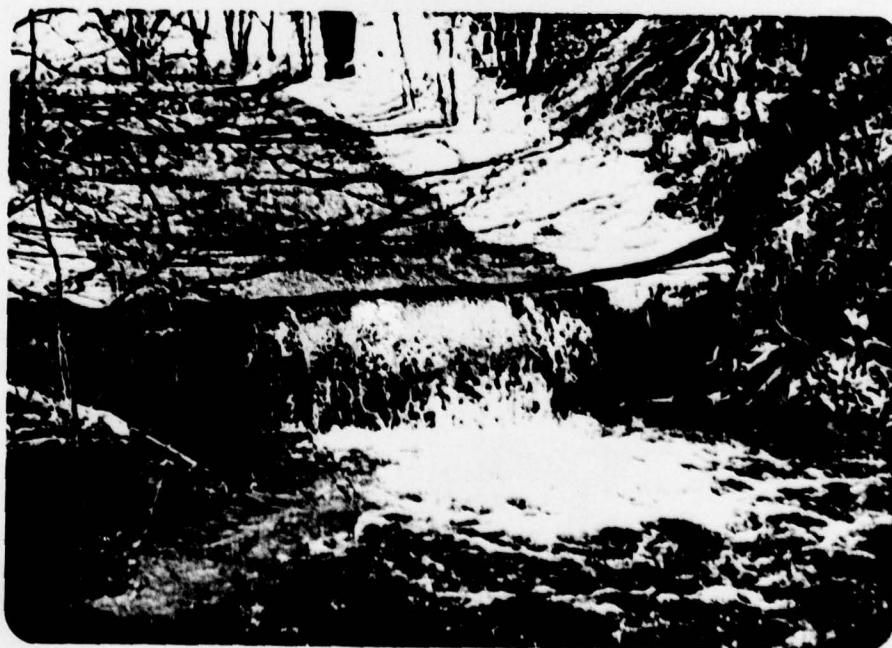
End of Spillway Chute

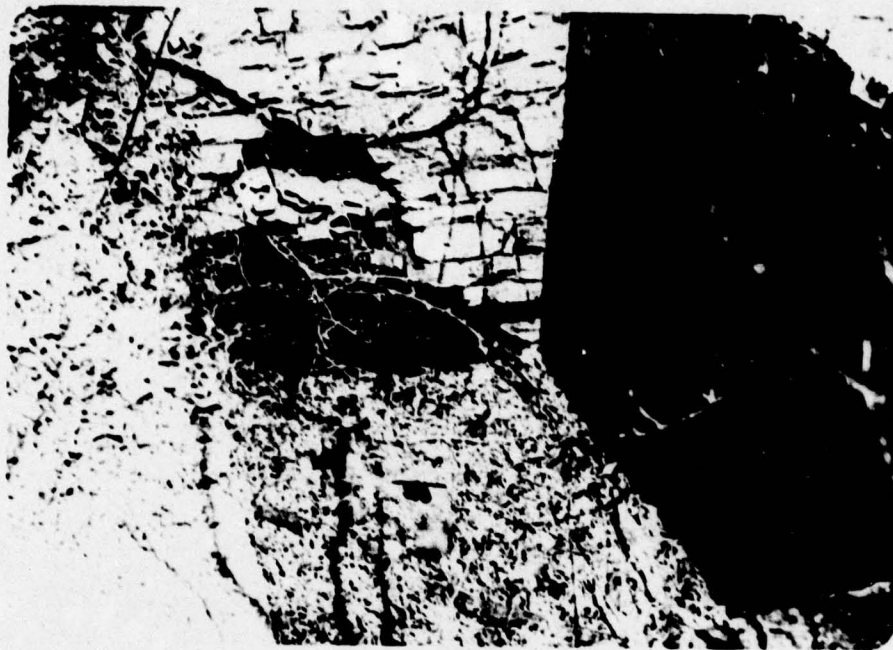
The reservoir has no intake structure. Only the foundation of an old pumphouse is left at the downstream toe near the right abutment. The rusty remains of an unidentified mechanism, possibly a gear valve, is located in the ruins of the pumphouse. It appears that the reservoir does not have any drawdown facilities.

Old Pump House
